## INSPECTION REPORT

Job # 9000 - 18th March 2020

This Pre-Purchase report has been especially prepared for:

### Vehicle Description

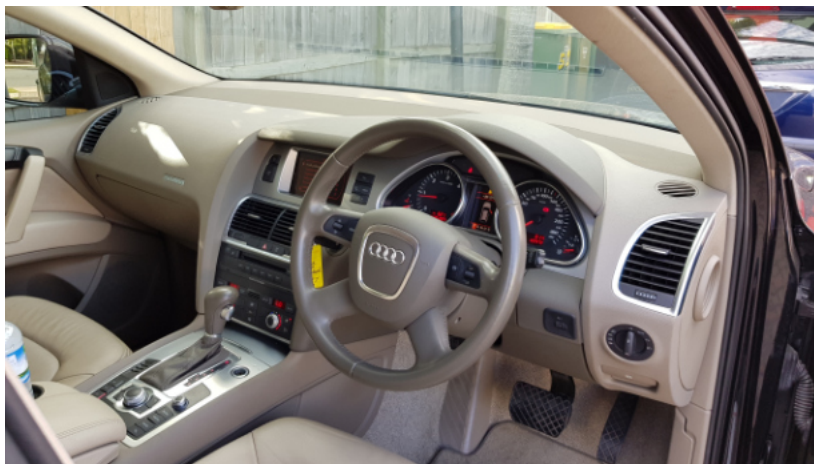
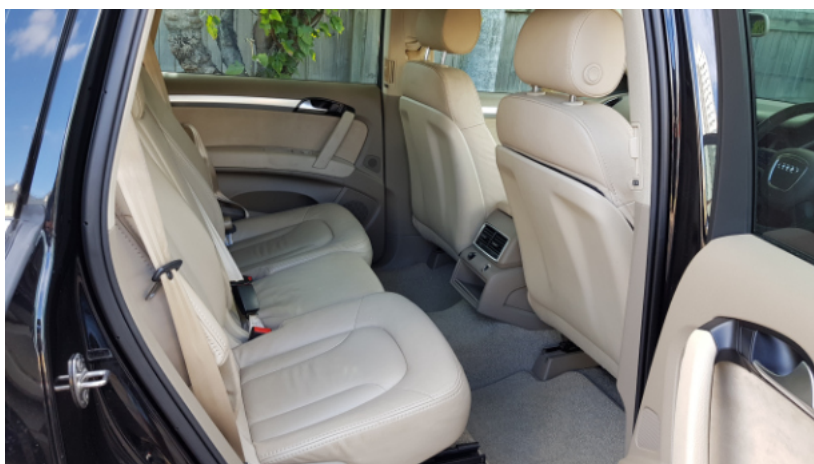
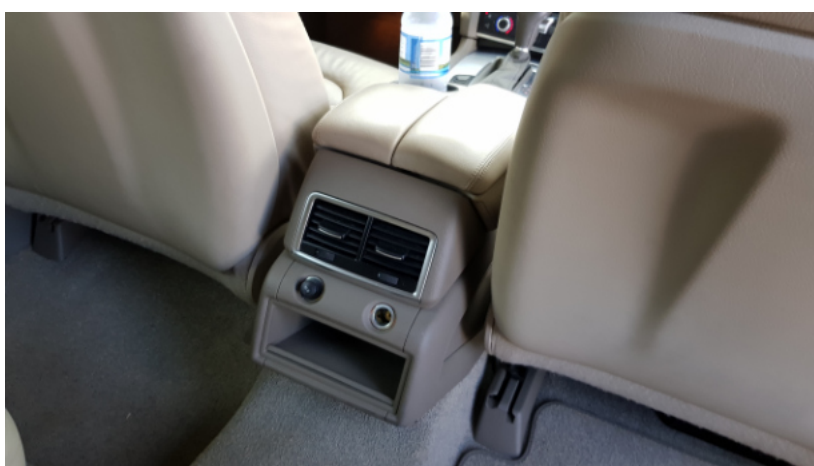
### Interior Visual Details

| <b>Trims Notes</b><br>Interior trims do have some minor scuff marks on the plastics, nothing major, marks may be able to come out if cleaned and detailed | |

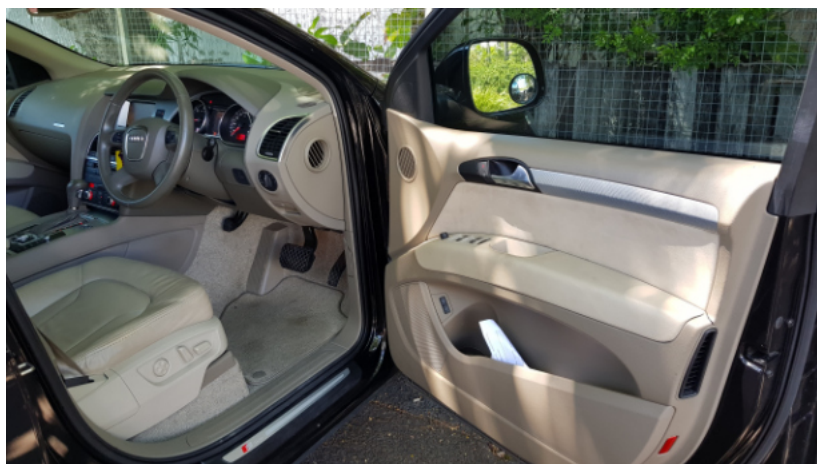
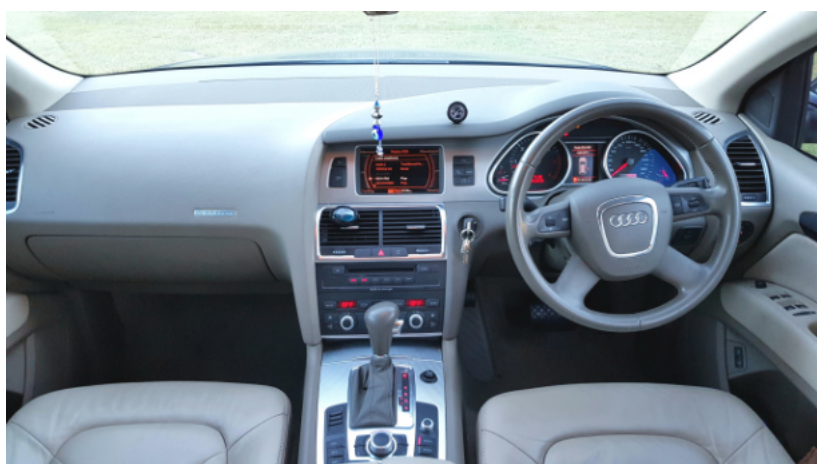
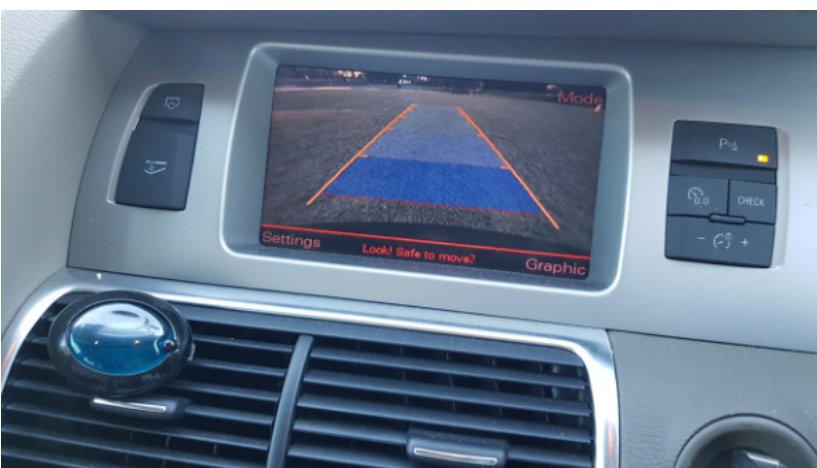
| <b>Warning Lights Notes</b><br>No engine warning lights evident, However messages on dash for oil change due and key remote battery low | |

Everything tested and checked in this section all operational besides one key that does not lock or unlock vehicle, noted some trims do have minor scuff marks, good detail should be able to remove marks

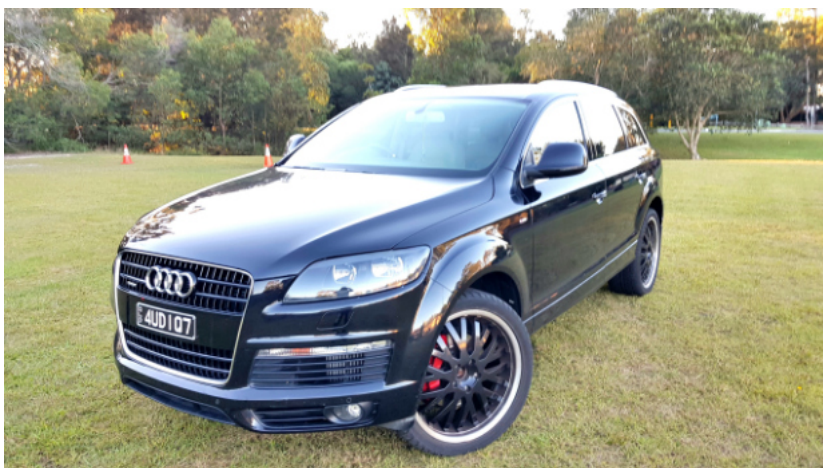
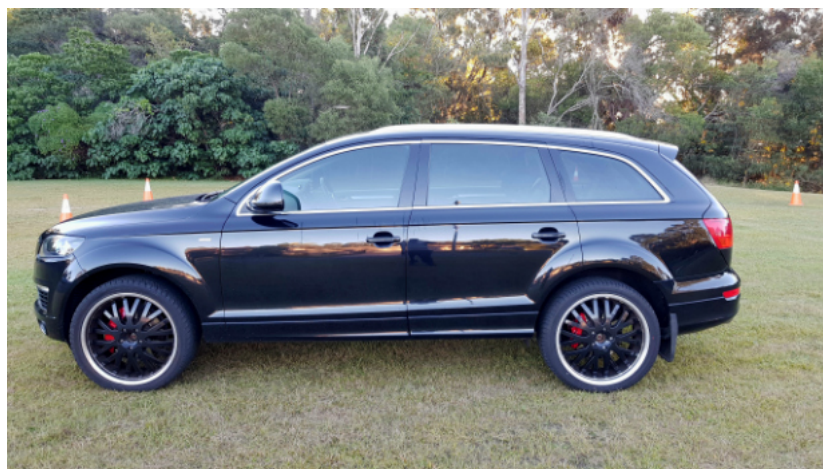
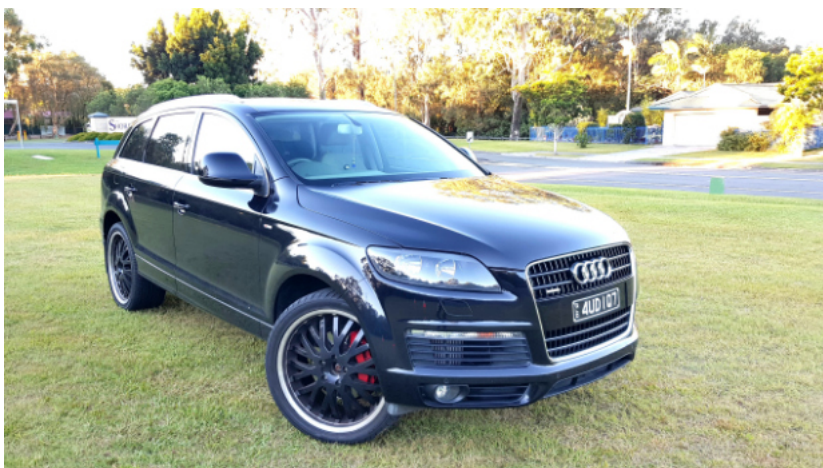
### Exterior Visual Details

| <b>Body Panels Notes</b><br>Vehicle was dirty when inspected.<br>Rear bumper has damage left hand side near fog light and lower plastic section near centre of rear bumper,<br>Small dent on right hand front quarter pannel just above body line.<br>Small dint right hand rear quarter near rear door on body line | |

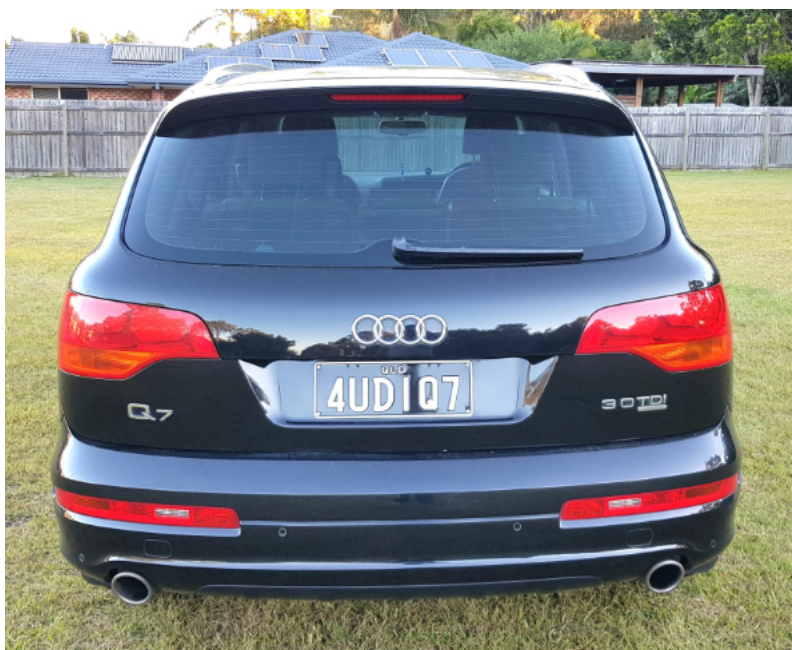
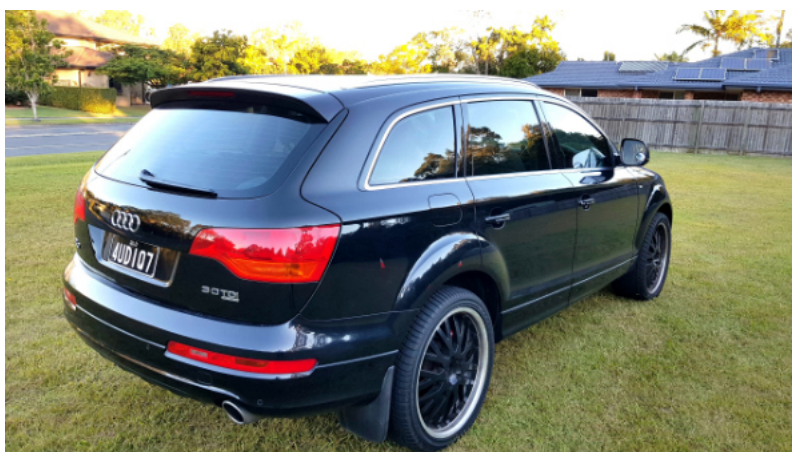
Please note in photo under vehicle, puddle on ground is just water from vehicles air conditioning

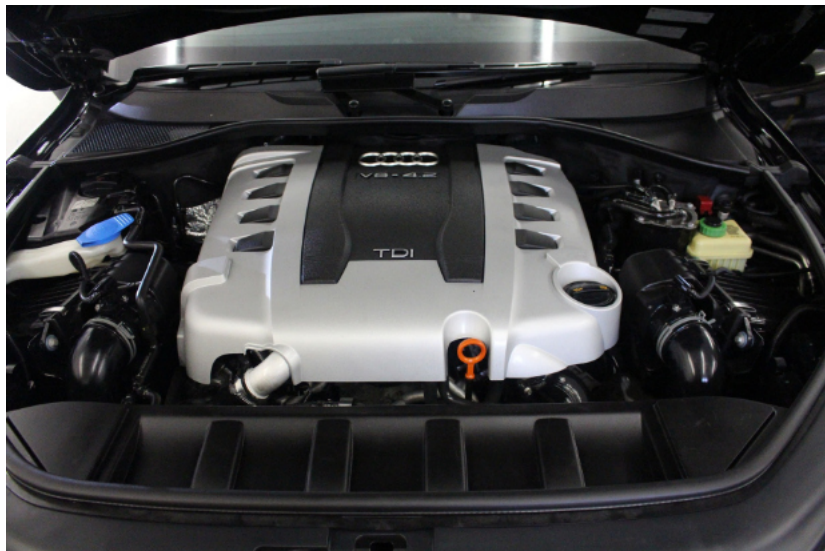
### Engine Bay Visual Details

Everything checked in this section all okay, vehicle is getting a new oil cooler fitted by the workshop next door later today

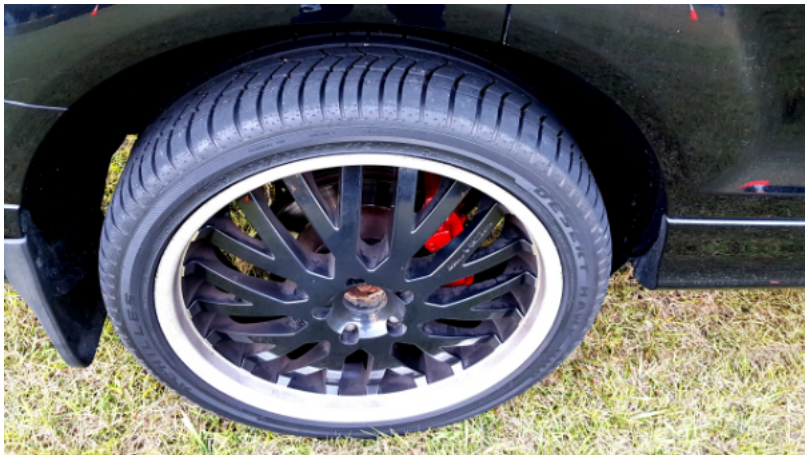
As outlined in second photo of the tyres you can see the age cracked i was talking about
